## **NORTH COAST INTEGRATED REGIONAL WATER MANAGEMENT PLAN**

### **North Coast Integrated Regional Water Management Plan Proposition 84 Round 1 Implementation Grant**

#### **Priority Project Technical Documents: Plans and Specifications**

##### **364 - Mendocino Jumpstart Integrated Water Plan, Mendocino County Water Agency/ Planning Department**

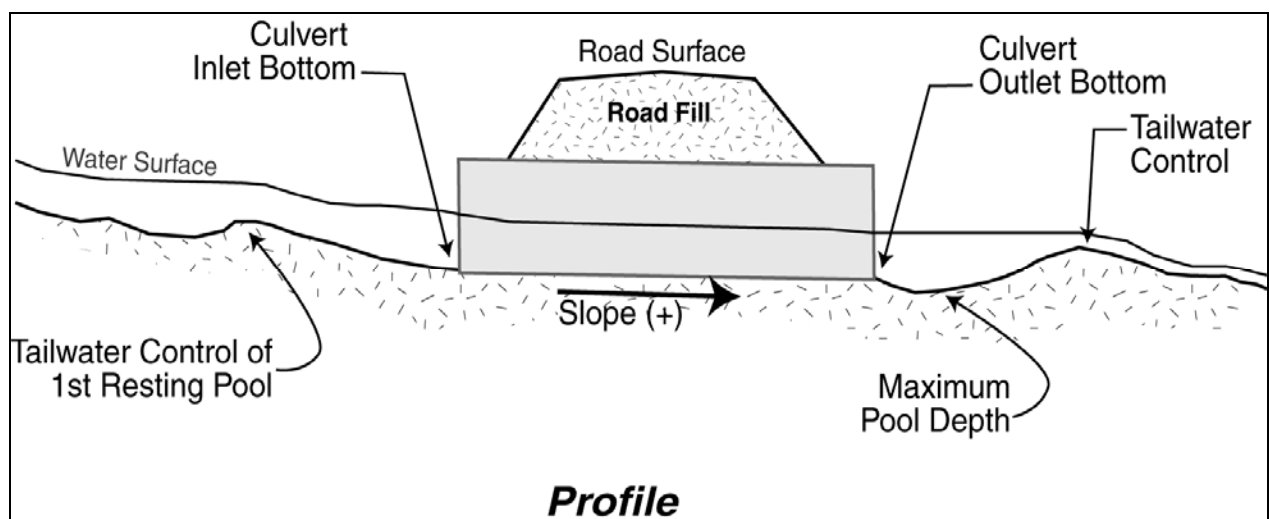
**Figure 1.** Diagram of required survey points through a culvert at a typical stream crossing.

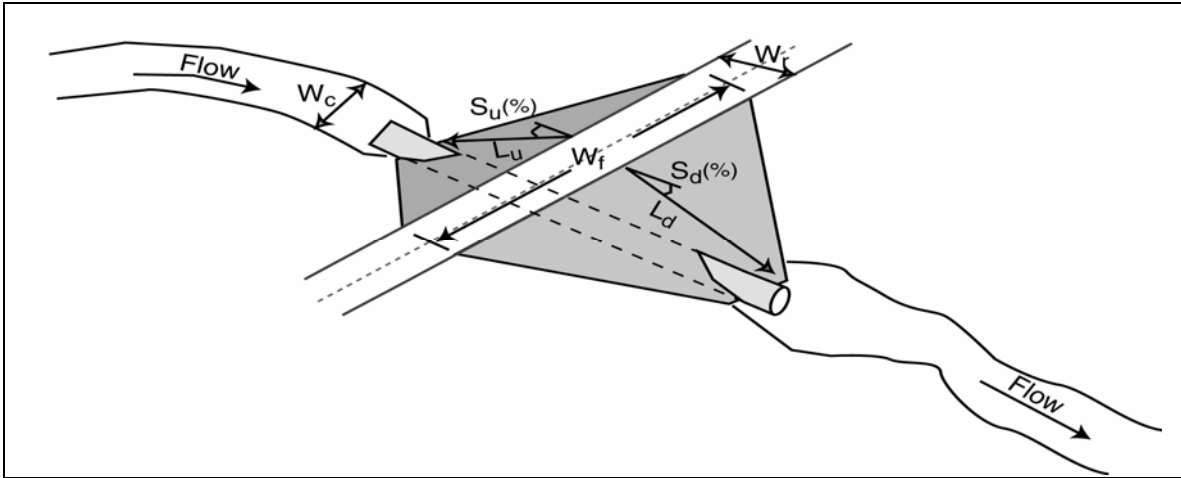
**Figure 2.** Road fill measurements.

Equations (1) through (4) were used calculate the fill volume.

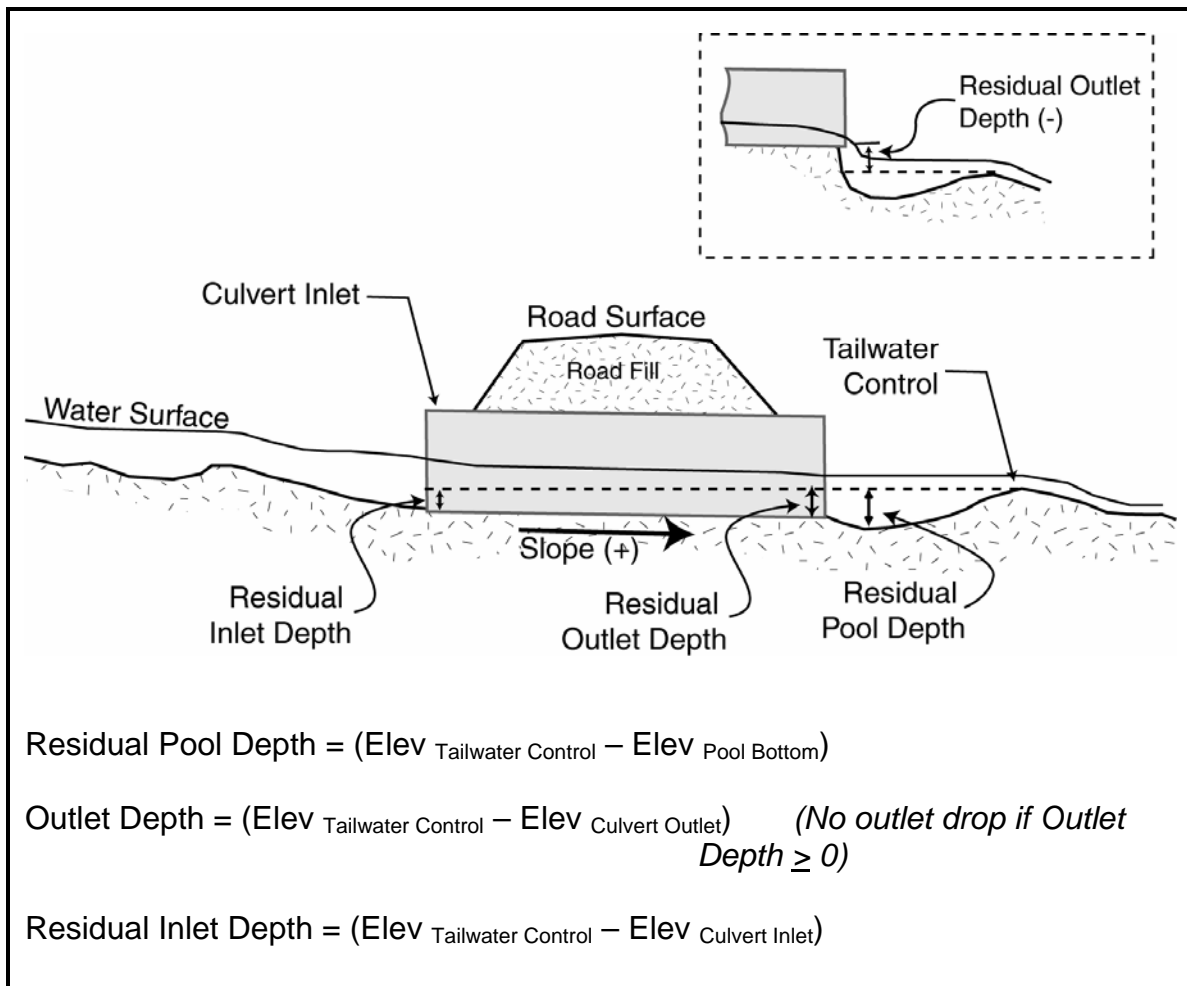
**Figure 3.** Measurements used in GREEN-GRAY-RED filtering criteria.

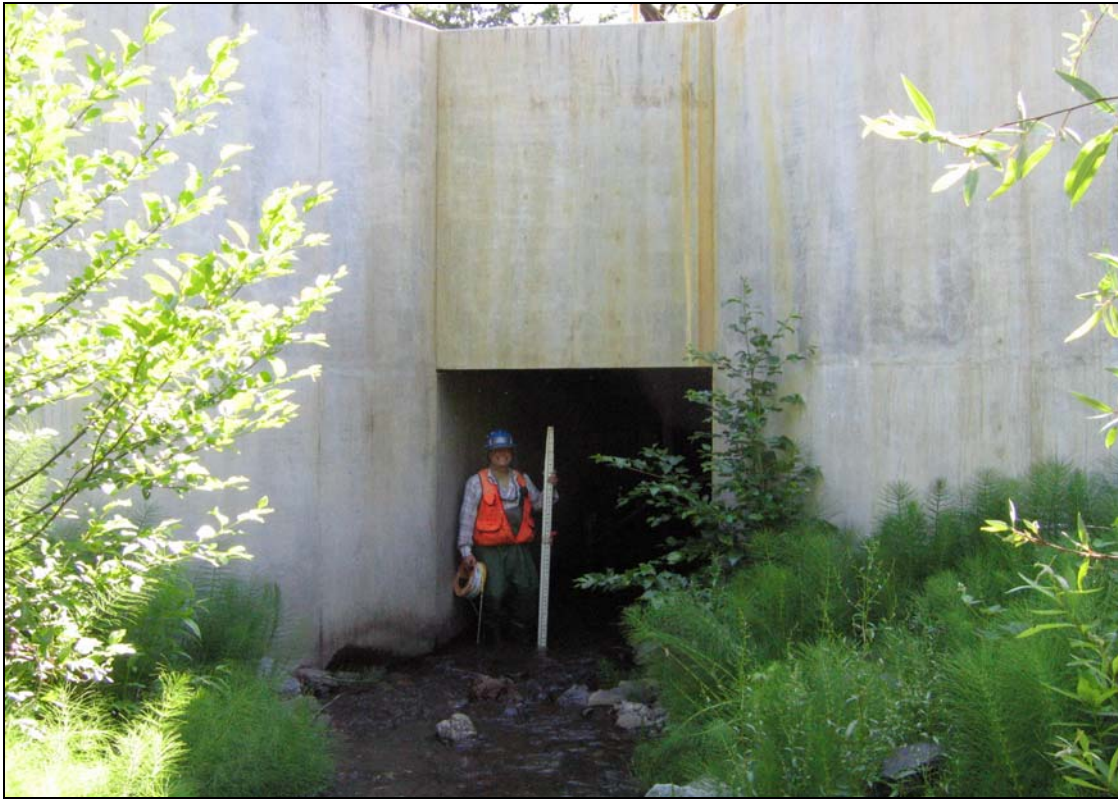
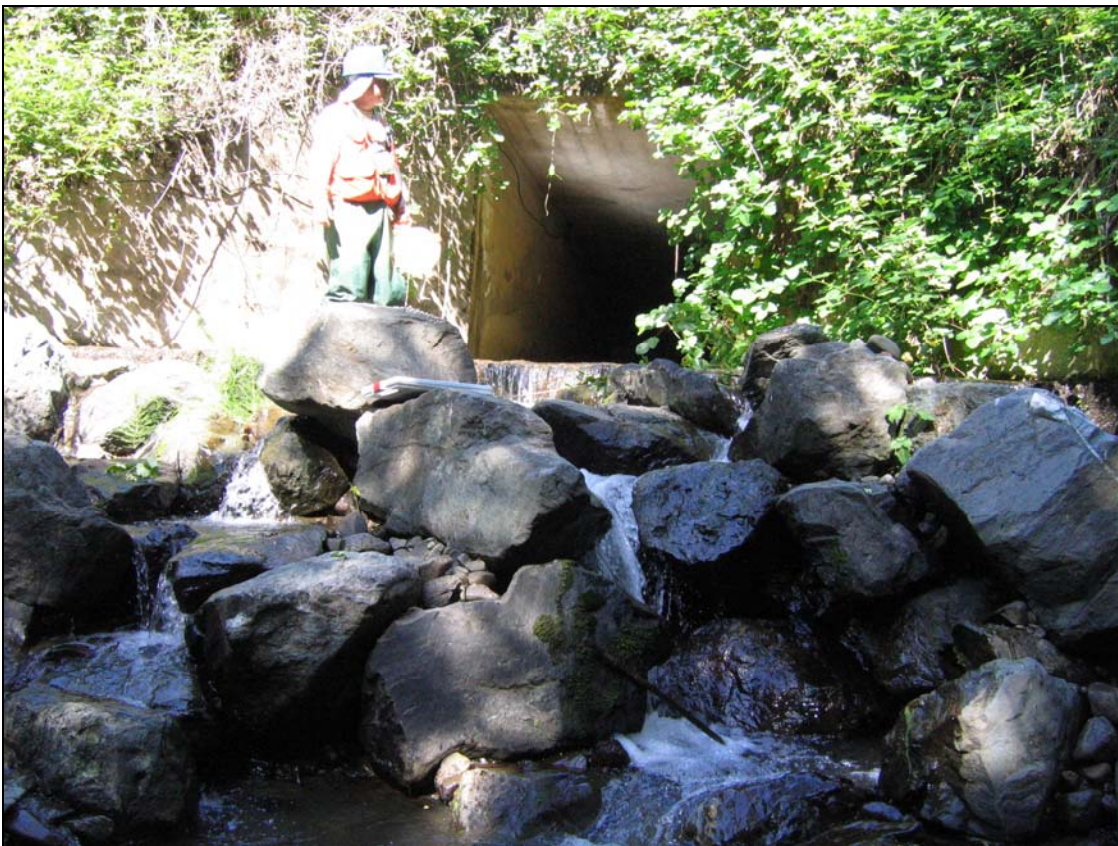
**Site ID #Pomo-02:** Tha-Layla Creek/Nokomis Road; Dooley Creek; Russian River

**Habitat:** Quantity = approximately 2,900' of potential fish-bearing habitat upstream of Site ID# Pomo-02. Quality = rated as "poor" for the ranking matrix – determined by Ross Taylor and Associates (RTA) observations at time of survey. No current habitat typing or fisheries surveys were available for this tributary. The crossing was surveyed by RTA on 05/25/06 and there were isolated areas of surface water. The survey crew noted a moderately dense riparian canopy, but poor habitat conditions within the active channel – extremely turbid water in isolated pools that were highly embedded with a sand/silt substrate.

**Preferred Treatment:** Because of the limited quantity of available upstream habitat and the poor quality of in-stream conditions, treatment of this site would not be cost-effective and would yield minimal benefit to salmonid populations within the watershed. Recommend periodic inspection of crossing for plugging of debris at the inlet and continued failure of the culvert invert. When the crossing is replaced for maintenance purposes, fish passage should be facilitated.

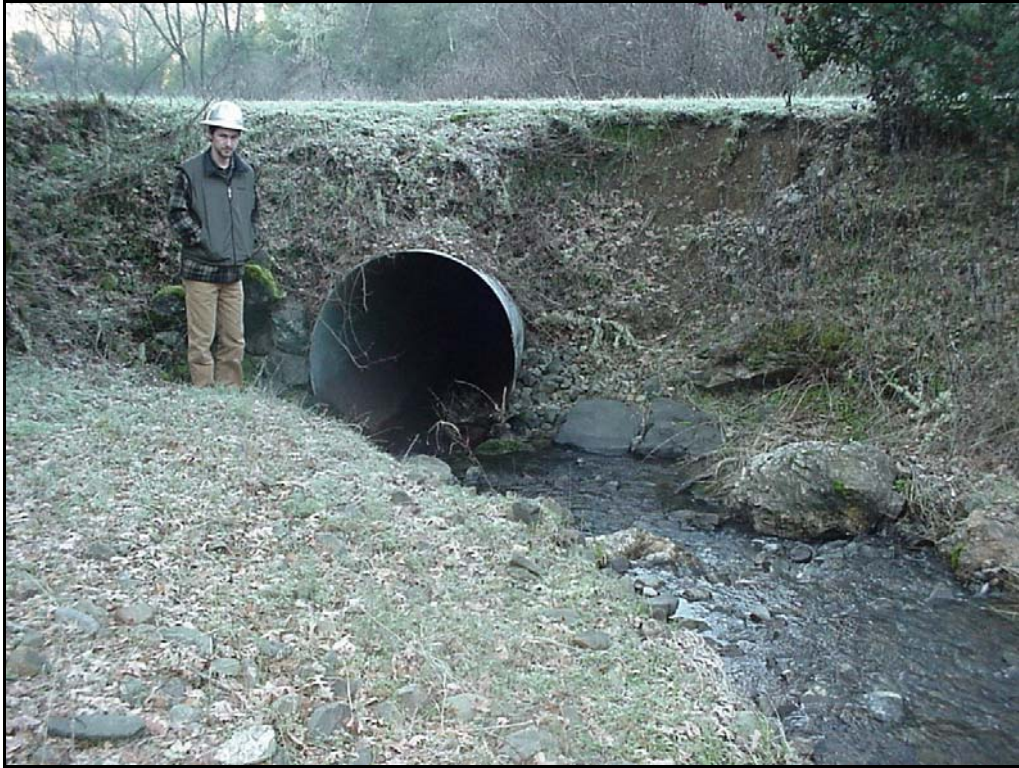
**Fill Estimate:** 335 cubic yards. **Overall condition:** Poor, culvert invert is rusted through.

**Preferred Treatment:** Because of current culvert's poor sizing and condition, a full replacement with a properly-sized open-bottom arch or a bridge is the best long-term solution. Grade-control may be required to minimize or control potential upstream head-cutting. Limited amount of poor-quality habitat upstream of this crossing renders this site a low-priority to treat with restoration funding.

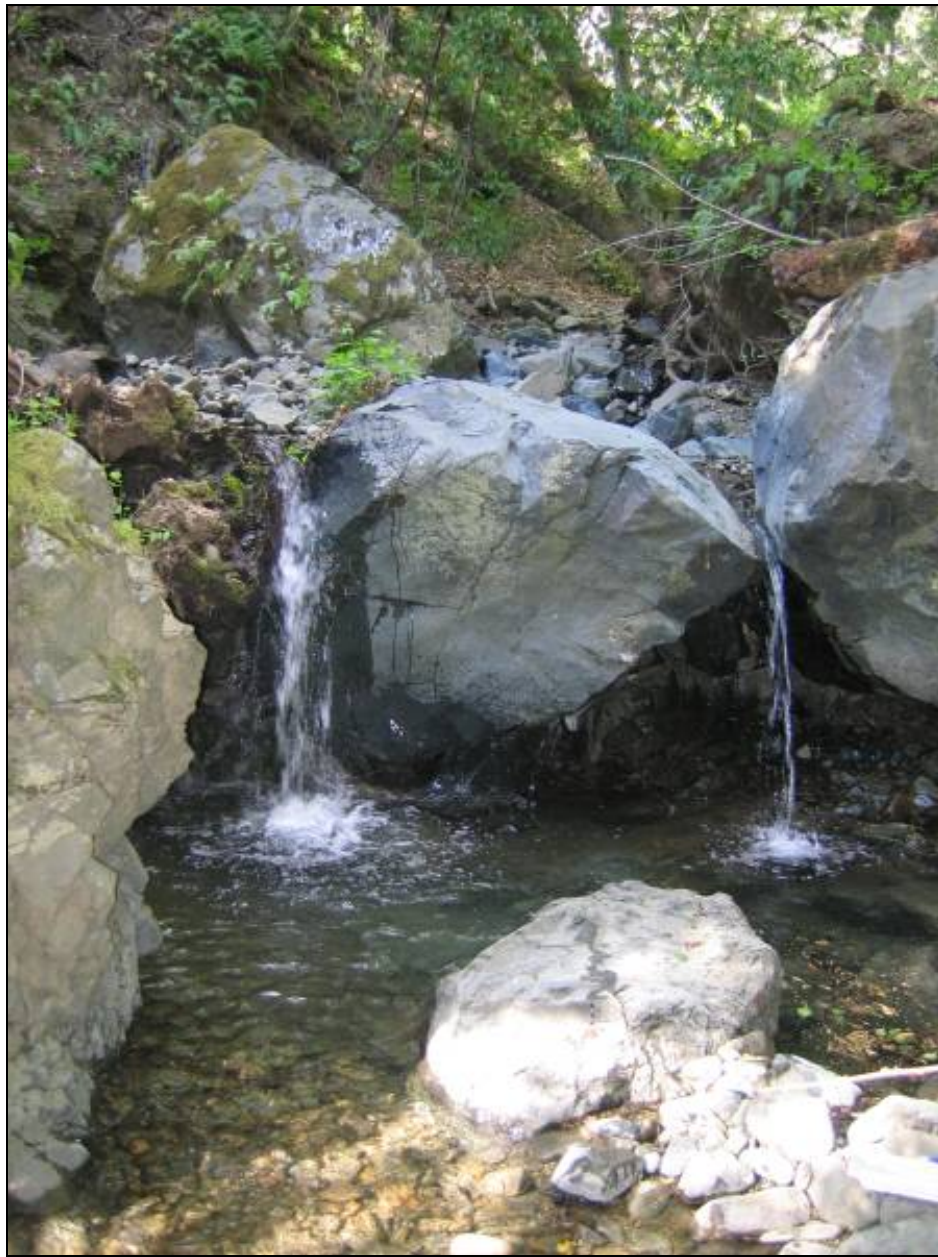
**Figure 2.** Plunge pool (Unit #304) on upper NissaKah Creek with a drop of approximately six to seven feet. No fish were observed upstream of this pool.

NissaKah Creek is a second-order stream with a drainage area of approximately 2.0 square miles. Watershed elevations are approximately 700' at the mouth to 2,800' at the headwaters. The confluence of NissaKah Creek and McDowell Creek is located approximately 250 feet upstream of the mouth of Angelica Creek (Figure 1). Just over 11,000 feet of NissaKah Creek's main channel was habitat-typed as delineated by the red line in Figure 1. The NissaKah Creek habitat typing survey was terminated within a reach with a slope greater than 7%, which was upstream of a reach with a slope greater than 13%. This steep reach was dominated by plunge pools over large boulders and bedrock (Figure 2).

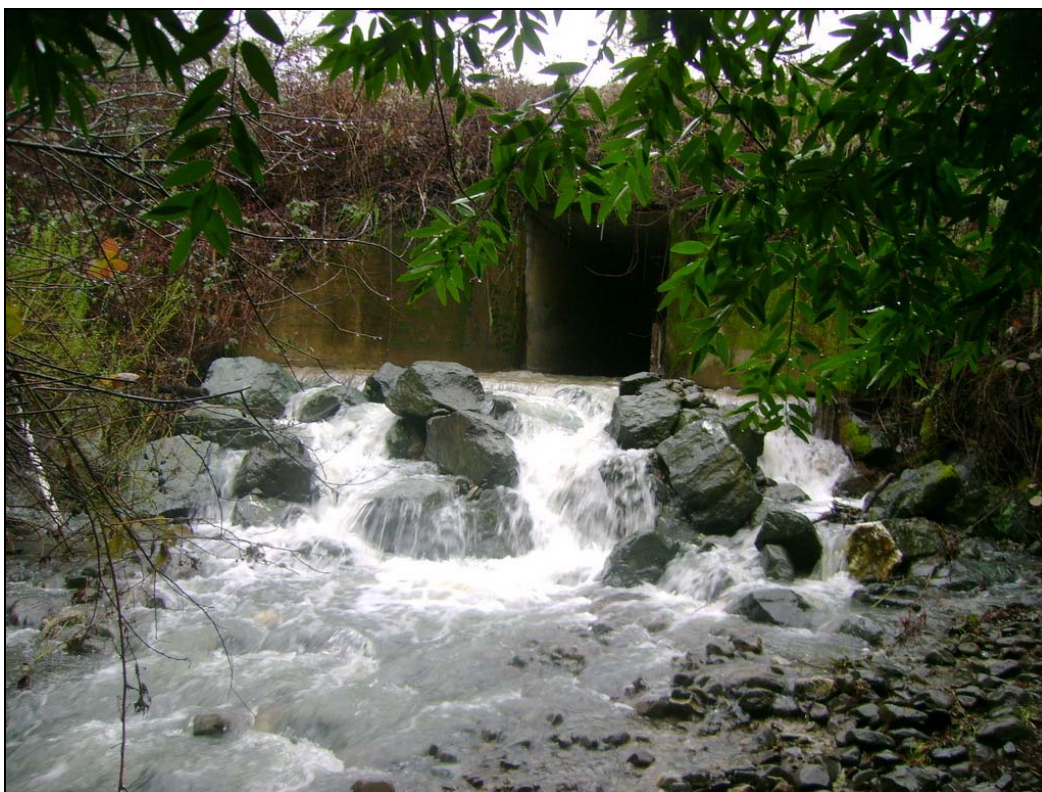
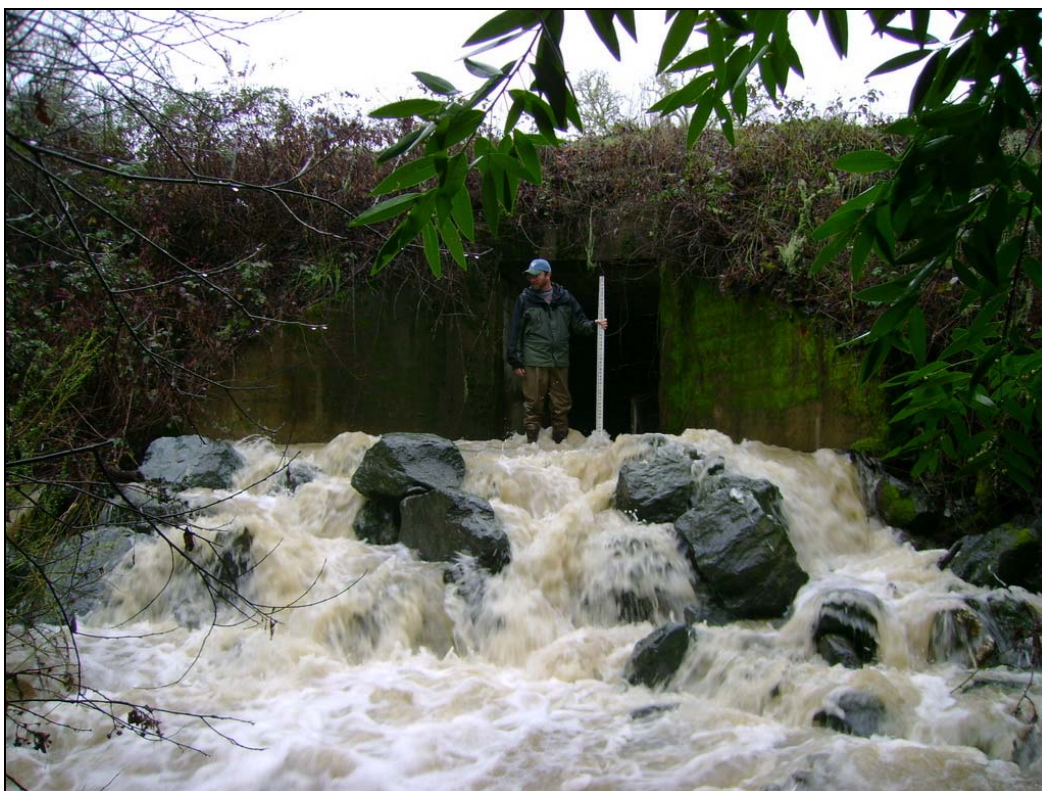
**Figure 3.** Rising flows on NissaKah Creek through the Nokomis road box culvert on January 31, 2008. Photos taken by Michael Love.

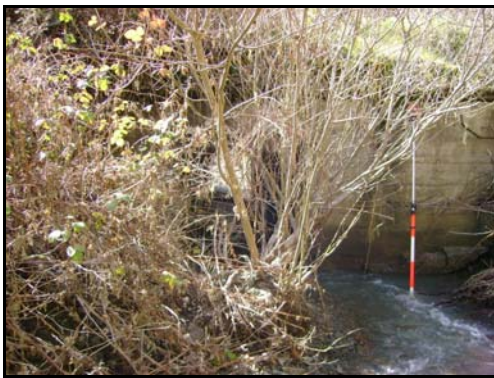
Figure 1: Culvert Inlet

The crossing consists of a single concrete box culvert. The culvert is 5.5 feet tall, 6 feet wide and approximately 56 feet long with a 1.38% slope. The culvert was constructed in 1919 and is owned and maintained by Caltrans.

Immediately upstream of the culvert, the creek makes a 90 degree turn. The channel upstream of the turn has a steep bank on river right and riparian on river left. As seen in Figure 1 (above), the riparian habitat has encroached on the culvert inlet. The steep bank on river right quickly climbs 70 feet above the creek.

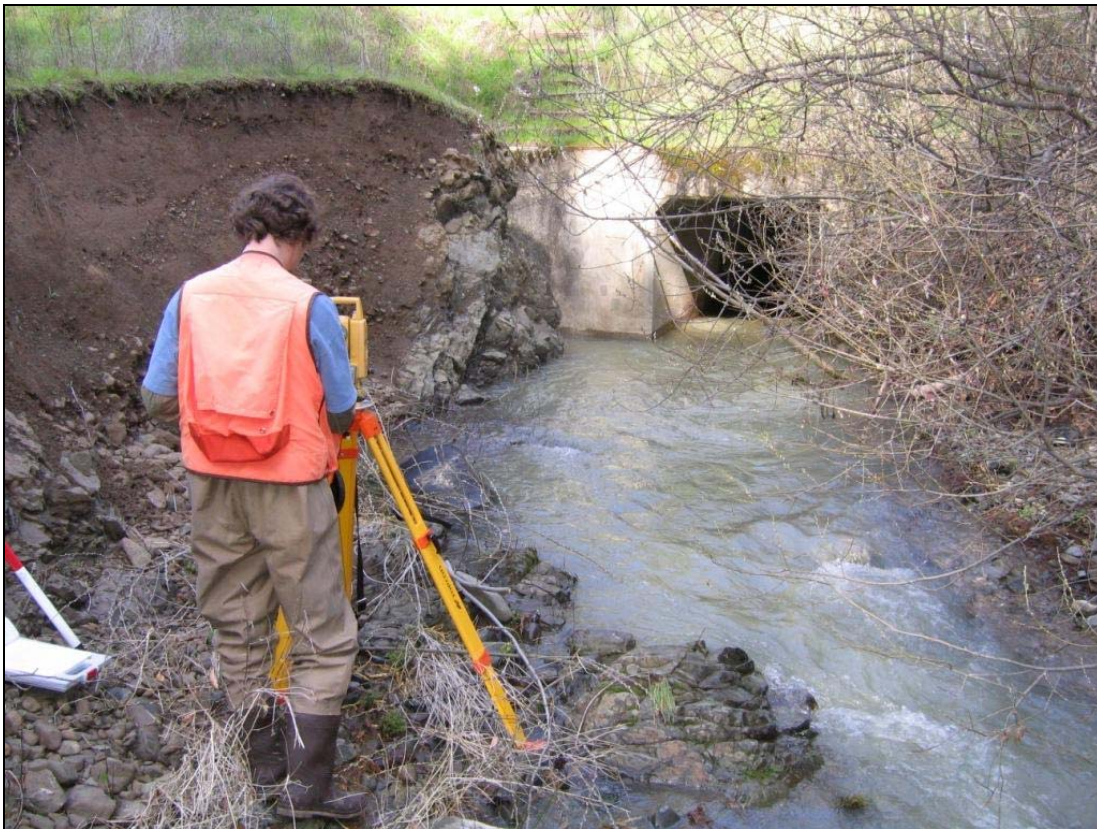
**Photo #1:** Highway 175 culvert on NissaKah Creek – looking upstream from below TWC.

Using the CDFG Section 9 criteria (more conservative than 8ft/sec-16ft/sec-0.5'), the culvert fails to meet all adult criteria – due to excessive velocities above 9 cfs and a lack-of-depth below 50 cfs.

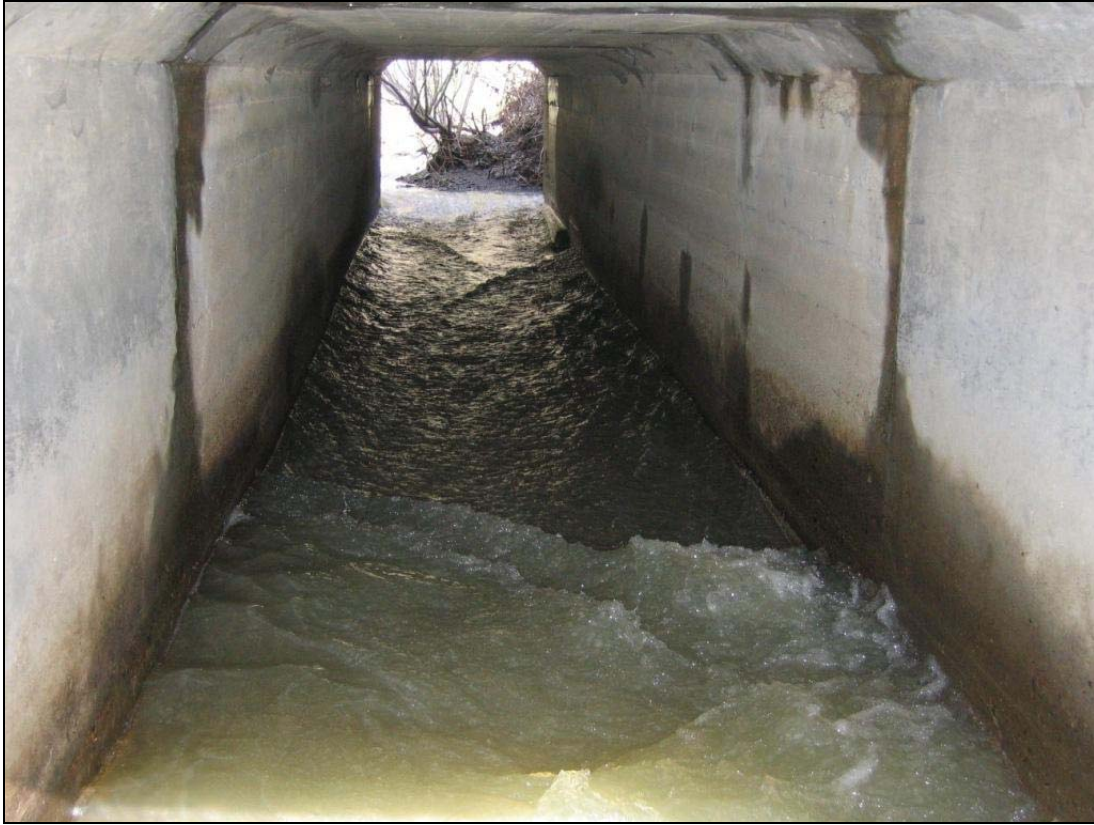
**Photo #2:** Highway 175 culvert on NissaKah Creek – looking upstream from outlet – note change in hydraulics at point where crossing had been lengthened from original construction.

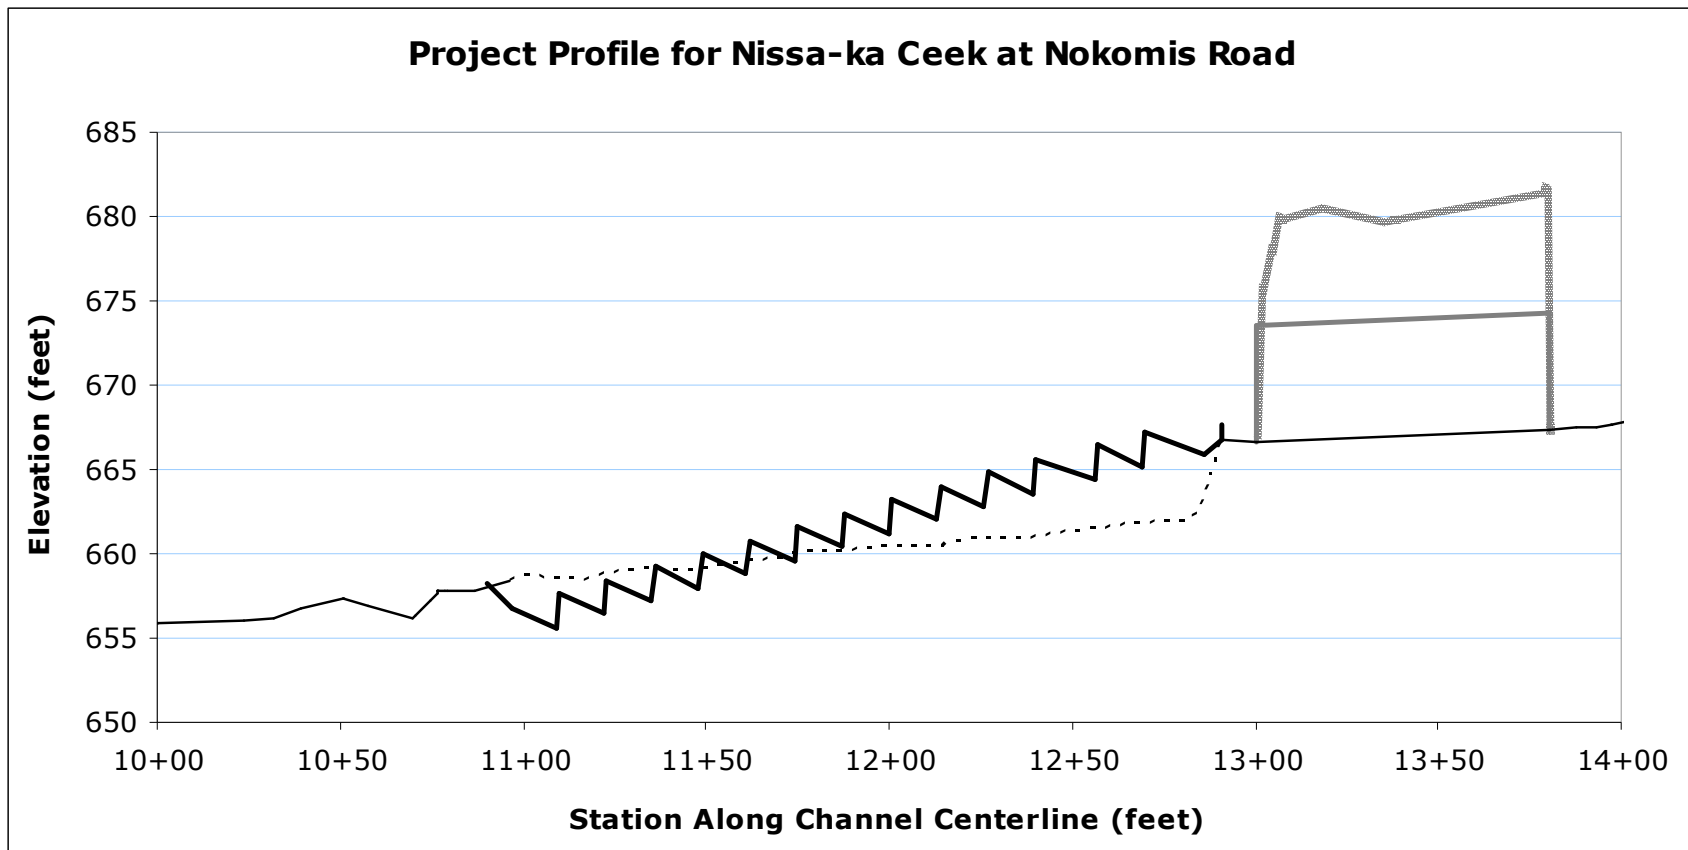
**Figure 1 - Existing (E) and new (N) profile through the centerline of the proposed roughened channel. Roughened channel is at an overall slope of 6% for 170 feet.**

Because the new channel is higher than the existing incised channel bed, the Tha-Layla Creek tributary will also require re-grading to provide positive flow into the main channel. The tributary channel will enter the new channel at the same elevation as the pool at station 12+50. The bankline of the new channel will conform to the tributary confluence. Approximately 40 feet of the tributary will be raised with engineered streambed material to match the grade of the new channel at the confluence. A rock step will be placed at the upstream end of the tributary section to provide grade control.

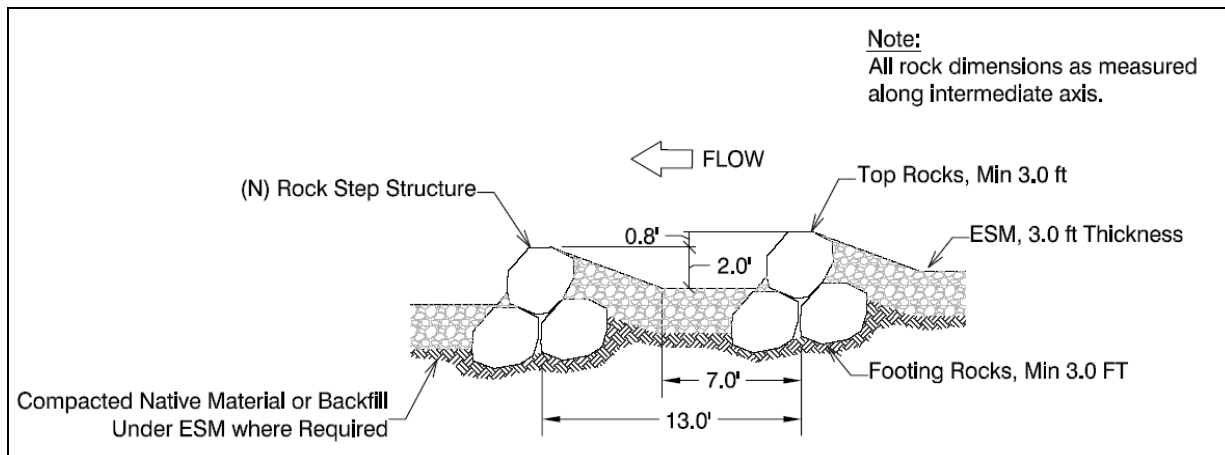
**Figure 4 - Profile of typical step pool sequence with drop between steps of 0.8 feet, pool spacing of 13 feet and residual pool depth of 2 feet. A Non-woven geotextile fabric (not shown in the above figure) has been specified in the 90% complete plans for placement between the ESM and the compacted native subgrade material. The geotextile fabric will reduce the loss of stream flow through infiltration into the native subgrade during low flows.**

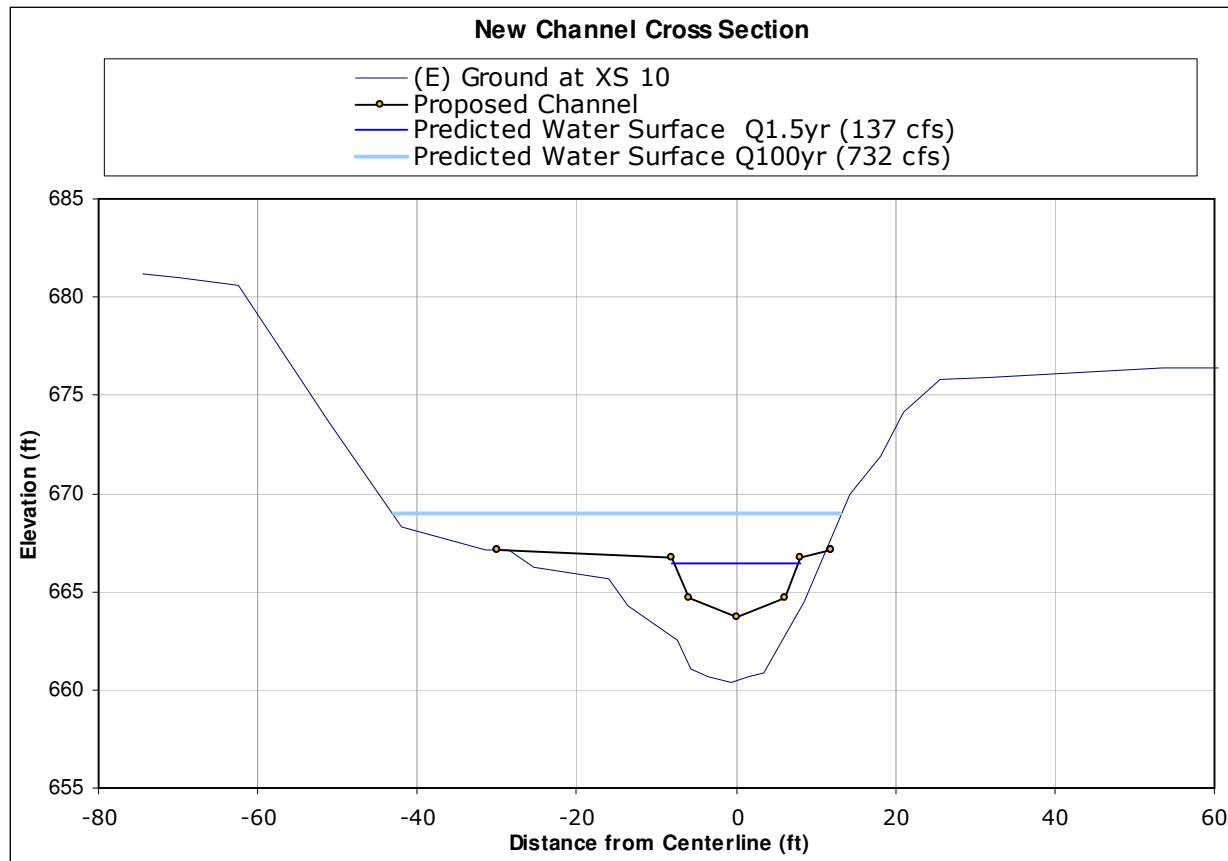
**Figure 5 - Predicted water surface elevations at Q1.5 (137 cfs) and Q100 (732 cfs) at cross section 12+00, located across a step approximately 100 feet downstream of the culvert outlet apron.**

Recurrence Interval	<u>Predicted Conditions</u>		
	Flow (cfs)	Water Depth (ft)	Water Velocity (ft/s)
1.5 year	137	2.7	4.9
100 year	732	4.8	6.3

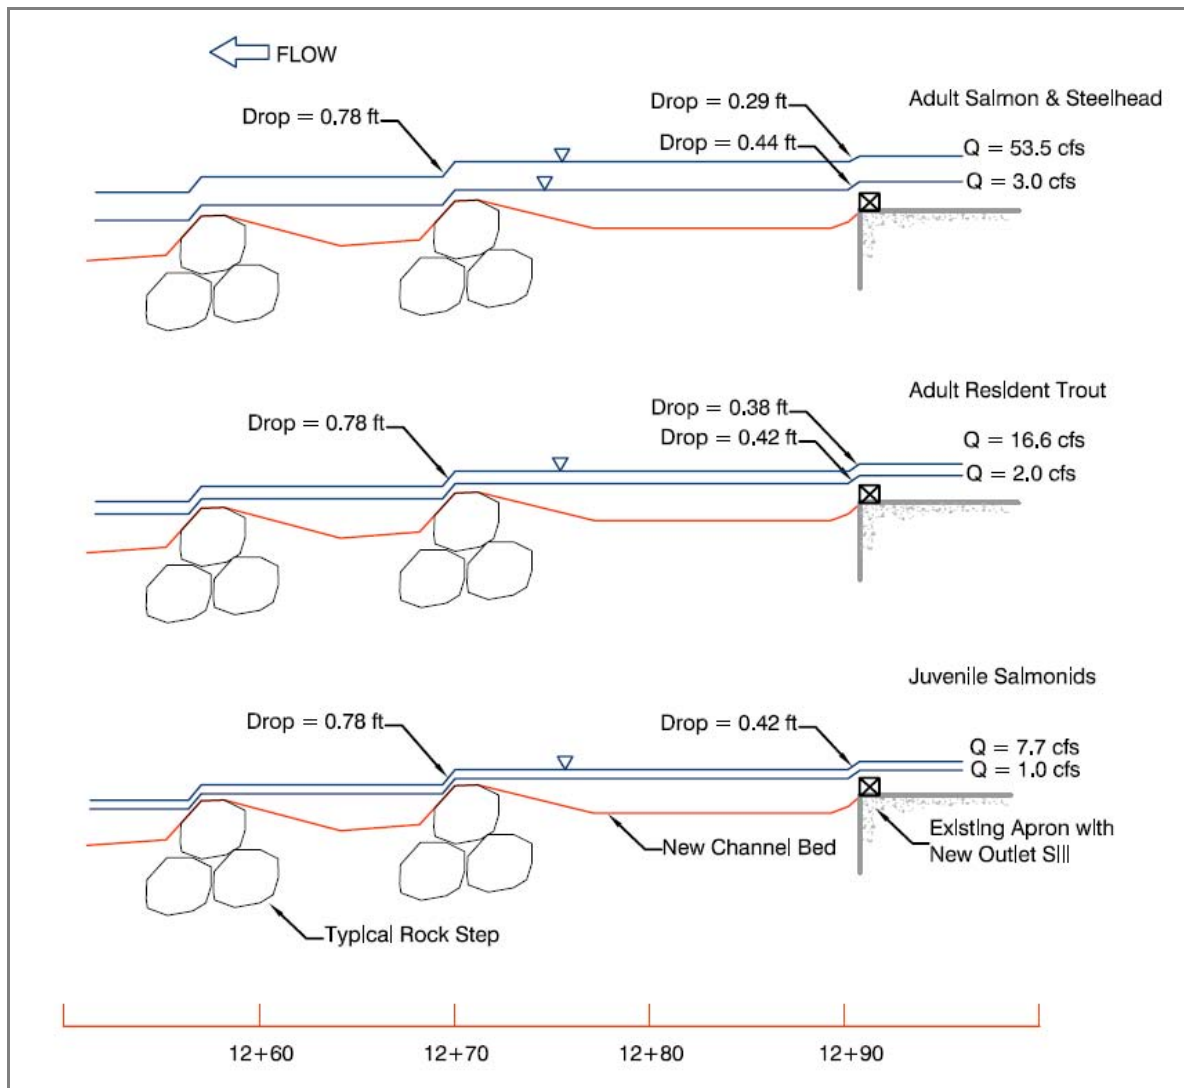
**Figure 6 - Predicted water surface profiles over the outlet sill and rock steps at each fish passage design flow.**

Using the predicted water depth over the sill at the various fish passage flows, conditions in the culvert were predicted using the FishXing 3.0 software and are summarized in **Tables 10** and **Table 11**.

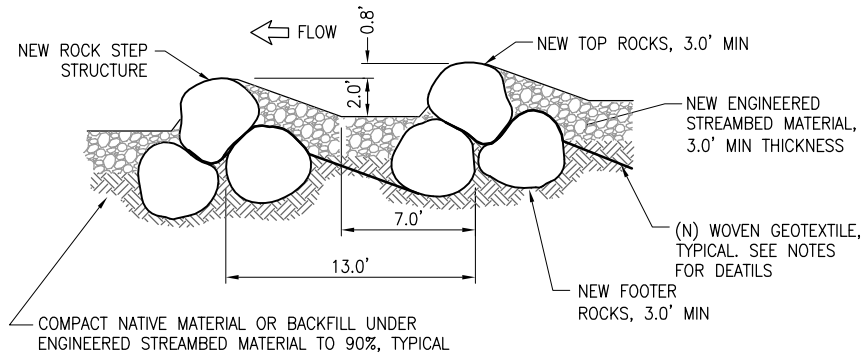
2 TYPICAL ROCK STEP STRUCTURE PROFILE  
TYP C-4 SCALE: SEE SCALE BAR
